gSKIN® application note: Measurement vs. Calculation

In this case study the theoretical U-value based on a calculation model is compared with a U-value based on a heat flux measurement with greenTEG's gSKIN sensor. An office wall at Technopark, a business and meeting centre in Zürich, has been assessed. The building is built in 1990 according to the highest energy standards and therefore reached excellent thermal characteristics for that time. The goal of this case study is to find out to what extent the U-value calculated with the construction data deviates from today's measured value.

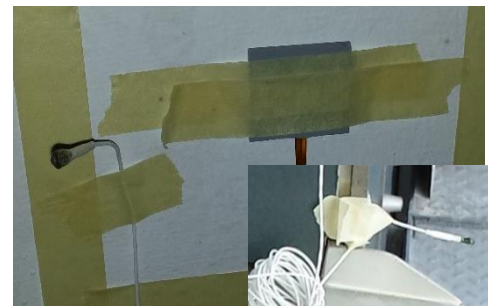
The heat flux sensor has been attached to the inside of the wall. The inside temperature sensor is placed next to it, approximately 3-4 cm from the wall. The outside temperature sensor is also attached 3-4 cm away from the wall (and not influenced by direct sunlight).

Figure 2: Above: Measurement set-up; heat flux sensor with inside temperature sensor, Bottom right: outside temperature sensor

The wall faces the West and is blocked from solar radiation by buildings nearby. The room in which the measurement is conducted is occupied during office hours. The measurement period has been roughly 72 hours to be in compliance with ISO 9869 and to reduce the effect of a daily temperature pattern within the room.
